U.S. Department of Transportation
Federal Highway Administration

Priority, Market-Ready Technologies and Innovations

Air Void Analyzer

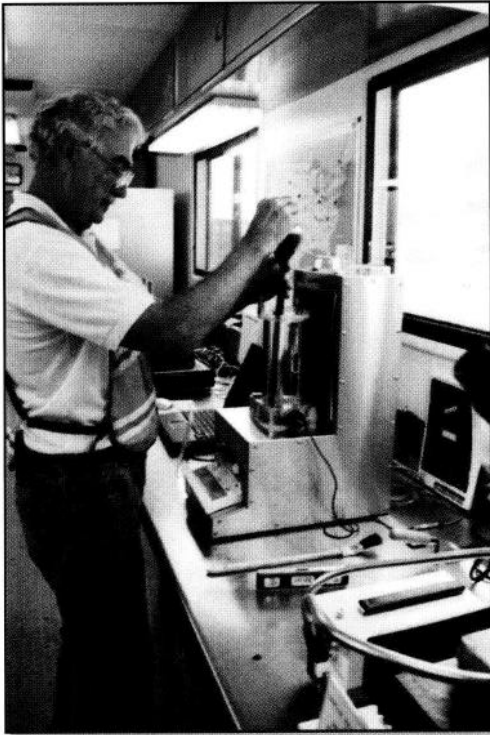
*Extracting
an AVA
sample*

The AVA uses a small mortar sample (20 milliliters (0.68 fluid ounces)) extracted from the surface of fresh concrete using a vibrating cage and a syringe. The extracted mortar is injected into an assembly containing liquids with carefully controlled viscosities. As the mortar is injected, the air bubbles are released and rise through the liquids toward a buoyancy recorder at the top of the assembly. The rate of rise of the bubbles is a function of their size. A data collection system tracks the change in buoyancy over time, and software determines the size distribution of the bubbles. From this data, the total air content, spacing factor, and specific surface are calculated.
